## Application Success Story

## Precision Bearing Assembly

### Skid Steer

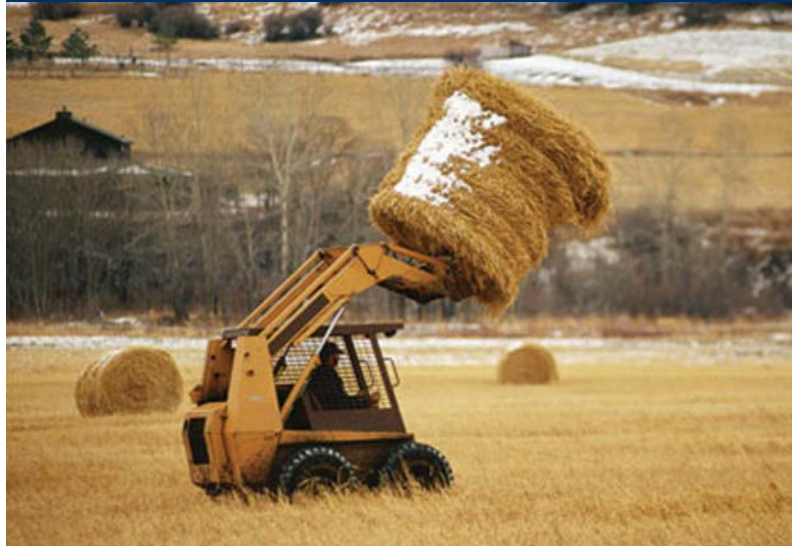
The manufacturer asked Kilian to help provide a solution. In response to the challenge, Kilian engineers developed a single, precision bearing assembly that minimized play and eliminated the O-rings that had worn down in the original system. This single assembly solution replaced eight components. It reduced the manufacturer's costs for the foot pedal assembly and for warranted equipment repairs.

The original assembly for the skid steer foot pedal, which is used to help maneuver the equipment, continually failed. The eight-piece foot pedal assembly featured a bushing inside the casting with two O-rings, which wore down. The excessive clearance in the assembly caused the control lever to slip, resulting in loss of vehicle control for equipment operators. This problem required the manufacturer to spend a great deal of time and money in the field to replacing the failing bushing system.
