## Precision Bearing Assembly

## Skid Steer

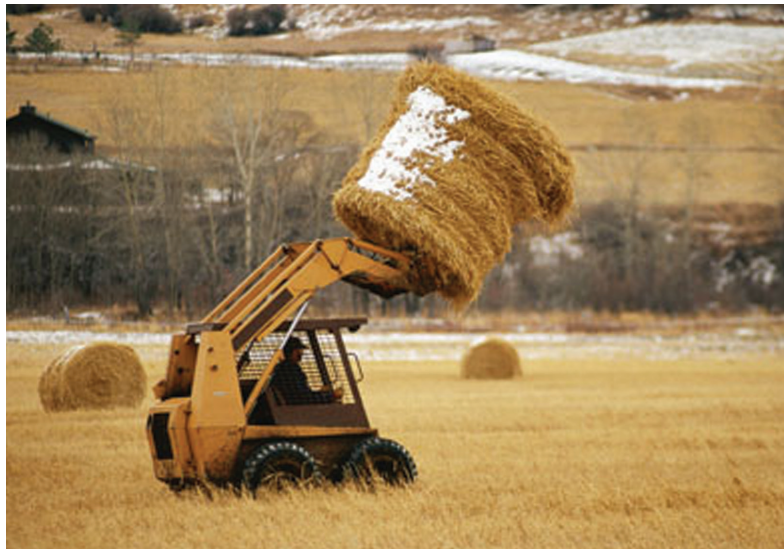
The original assembly for the skid steer foot pedal, which is used to help maneuver the equipment, continually failed. The eight-piece foot pedal assembly featured a bushing inside the casting with two O-rings, which wore down. The excessive clearance in the assembly caused the control lever to slip, resulting in loss of vehicle control for equipment operators. This problem required the manufacturer to spend a great deal of time and money in the field to replacing the failing bushing system.

The manufacturer asked Kilian to help provide a solution. In response to the challenge, Kilian engineers developed a single, precision bearing assembly that minimizes play and eliminates the O-rings that had worn down in the original system. This single assembly solution replaced eight components. It reduced the manufacturer's costs for the foot pedal assembly and for warranted equipment repairs.
